**United States Environmental Protection Agency
EPA New England
One Congress Street, Suite 1100
Boston, MA 02114-2023**

RE: June 2004 Monthly Report
1.5 Mile Reach Removal Action
GE-Pittsfield/Housatonic River Site

Dean Tagliaferro
1.5 Mile Reach Removal Action Project Manager

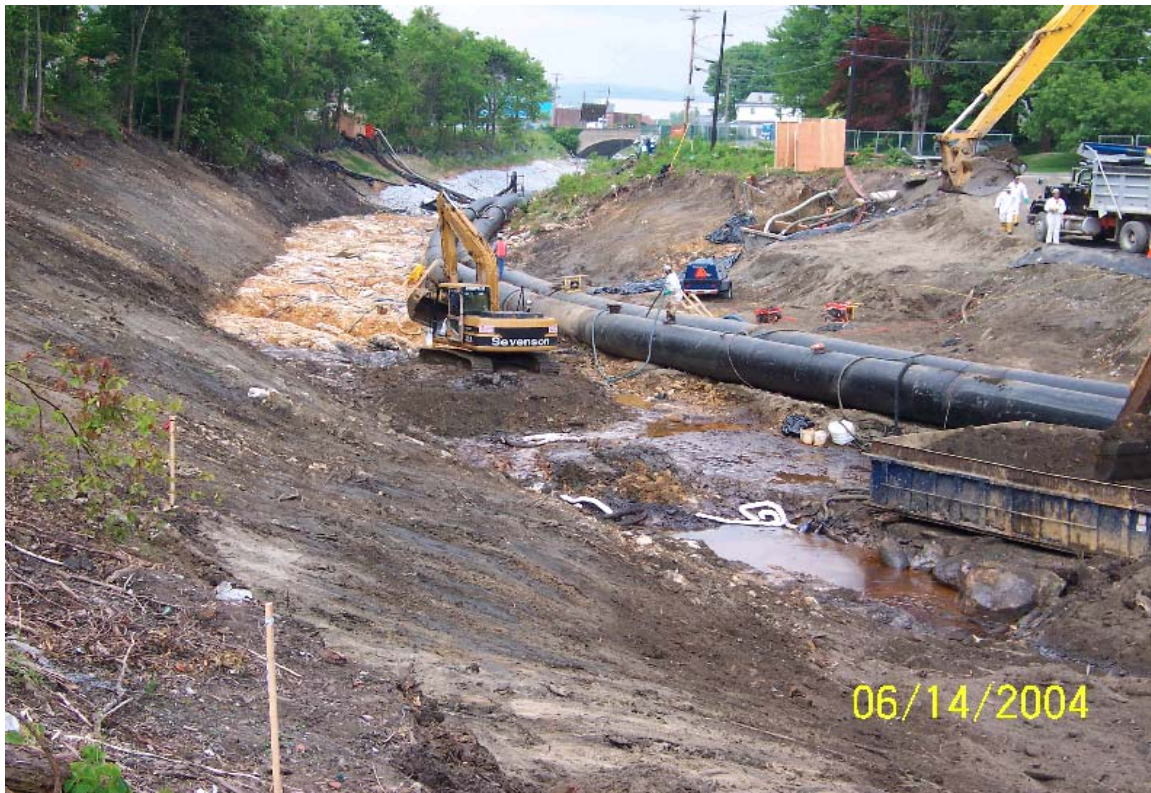
Photograph 1 – Excavation Activities in Cell 17W

During the fourth week in June, the riverbed and riverbank excavation activities continued in Cell 17W. The non-TSCA riverbank material pre-characterized for offsite disposal was excavated and transported to Area 64D; the non-TSCA riverbed material uncharacterized for offsite disposal was transported to Area 64C; the riverbed cobble material was transported to Area 64E. Additional NAPL-impacted material was encountered during the riverbed excavation in both Cells 16W and 17W. The small track excavator was continuously used to access and remove the NAPL-impacted material from the areas of the river bottom where the weathered bedrock contained crevasses and depressions.

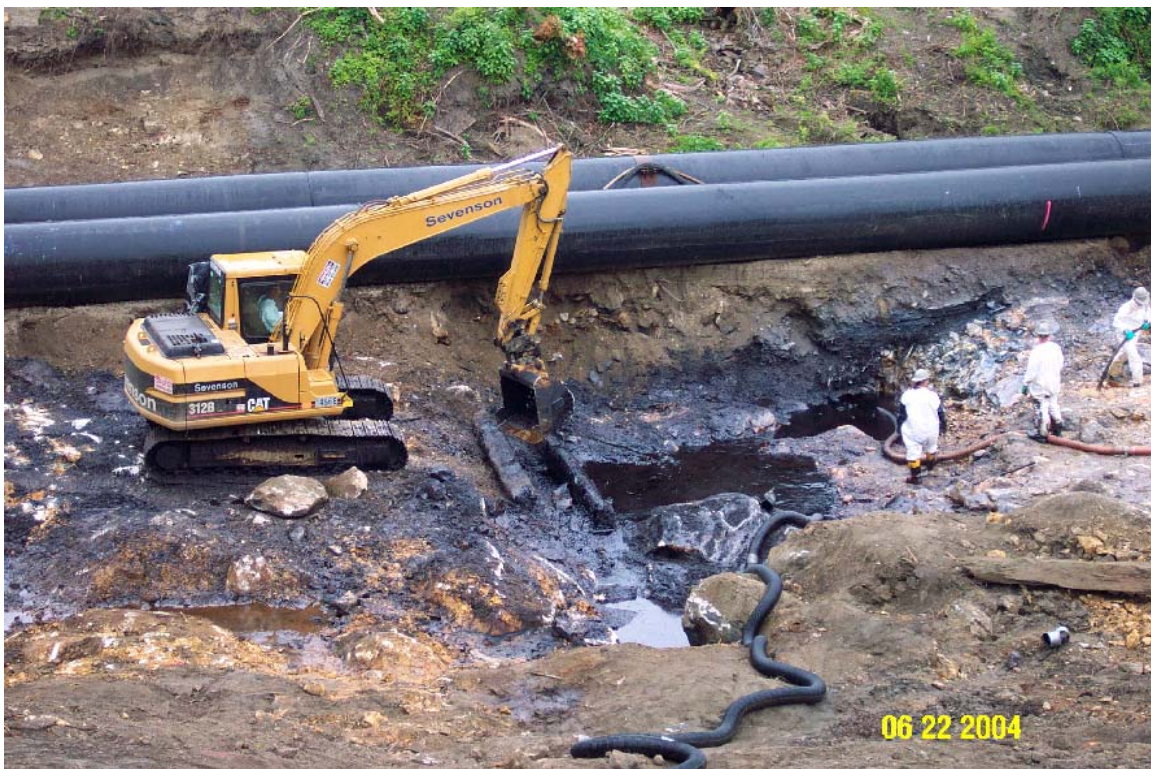
Photograph 2 – Excavation of NAPL Activities in Cell 17W

Most of the depressions in the bedrock were two to three feet below the original sediment grade. In one forty by ten foot area, due to the presence of NAPL-impacted material, the excavation depth was extended to eighteen feet below grade, where bedrock was encountered. There appeared to be a remnant of the timber dam in this area. All the NAPL-impacted material was excavated and transported to the Building 65 stockpile management area. The high pressure power washing and the vacuuming of bedrock to remove any visible sediment and NAPL staining continued. All of the water and the free flowing NAPL from the excavation areas and the water generated during the power washing were diverted to the water treatment system.

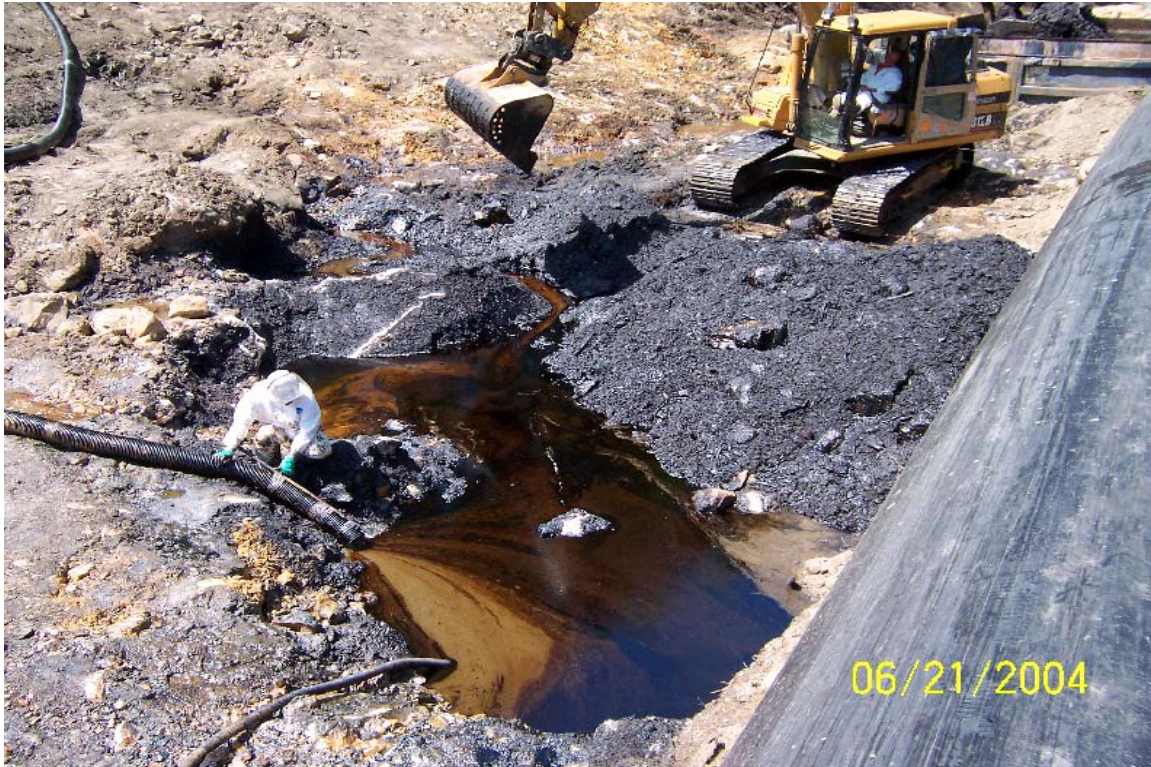
Photograph 3 – Removal of NAPL by Vacuum Truck

the river bottom in Cell 16W. Any visible NAPL was cleaned up using the vacuum truck and the bedrock was encapsulated with a grout mixture. Backfilling activities continued in Cell 16W after the grout was installed.

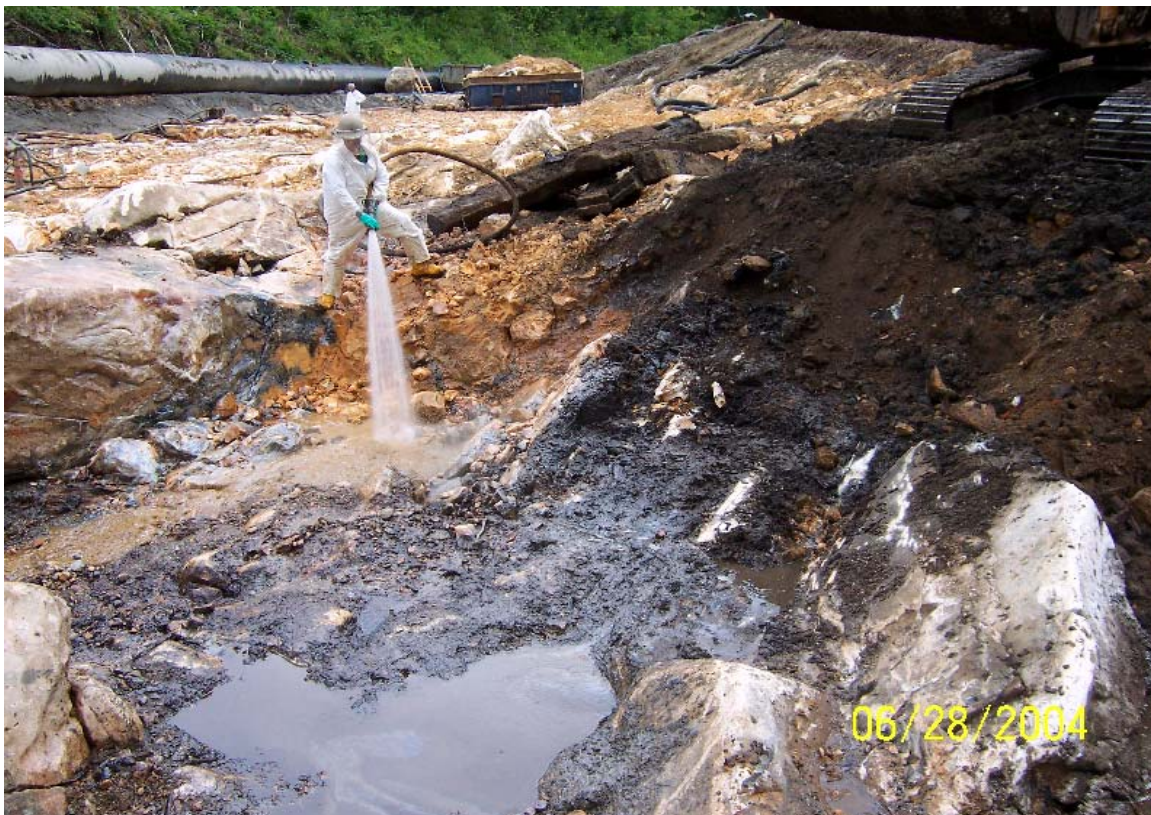
Photograph 4 – High Pressure Washing of NAPL-Stained Bedrock

Bedrock was encountered in the entire river bottom of Cell 16W and 17W. In most areas, there were less than 2-feet of sediment above the bedrock. Most of the bedrock within the riverbed was stained with NAPL. The high pressure power washing of bedrock to remove any loose sediment and NAPL staining was initiated. High pressure power washing of bedrock was supplemented with a vacuum truck to remove any residual sediment and NAPL from the bedrock. All water generated during the power washing was diverted to the water treatment system. All the residual sediment material was collected into roll off boxes located in the riverbed and subsequently transferred to the water treatment system modutank.

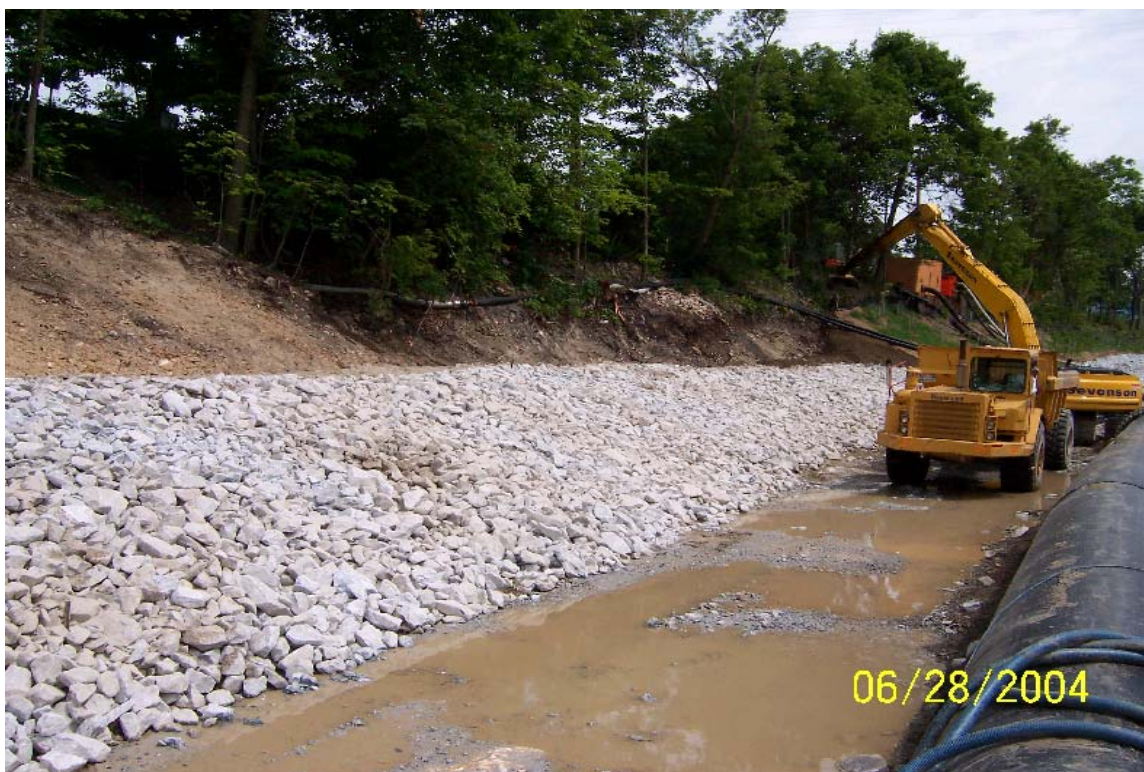
Photograph 5 – Riverbank Backfilling Activities in Cell 16W

Also, during the fourth week of June, the survey contractor completed the final excavating verification surveys in Cell 16W and backfilling activities were initiated. Absorption pads, filter fabric and a sacrificial layer of common fill were placed along the riverbed in Cell 16W to create a barrier between the Cell 16W and 16E interface. This barrier was created to prevent any cross contamination between the already excavated/clean Cell 16W riverbed from the contaminated Cell 16E riverbed prior to any backfilling activities. Due to the presence of bedrock within the entire riverbed of Cells 16 and 17 excavation depths varied. Therefore, various backfill configurations were developed to meet the design requirements. In the low lying areas and depressions in bedrock 12-inch riprap will be placed to bring the elevation up to grade. Areas of the riverbed where the excavation depth was greater than 3 feet will be backfilled with a layer of common fill, filter material then 12-inch riprap. Areas of the riverbed where the excavation depth was less than 2.5 feet will be backfilled with a layer of filter material then 12-inch riprap. Areas of the riverbed where bedrock was encountered at very shallow depths will be backfilled with common fill or will be left with the bedrock exposed. The riverbank will be backfilled with common fill or structural fill, a six inch layer of filter material and an 18-inch layer of 12-inch riprap up to an elevation ranging between 971 feet and 972 feet. The riverbank above those elevations will be backfilled with common fill and a 6-inch layer of top soil.

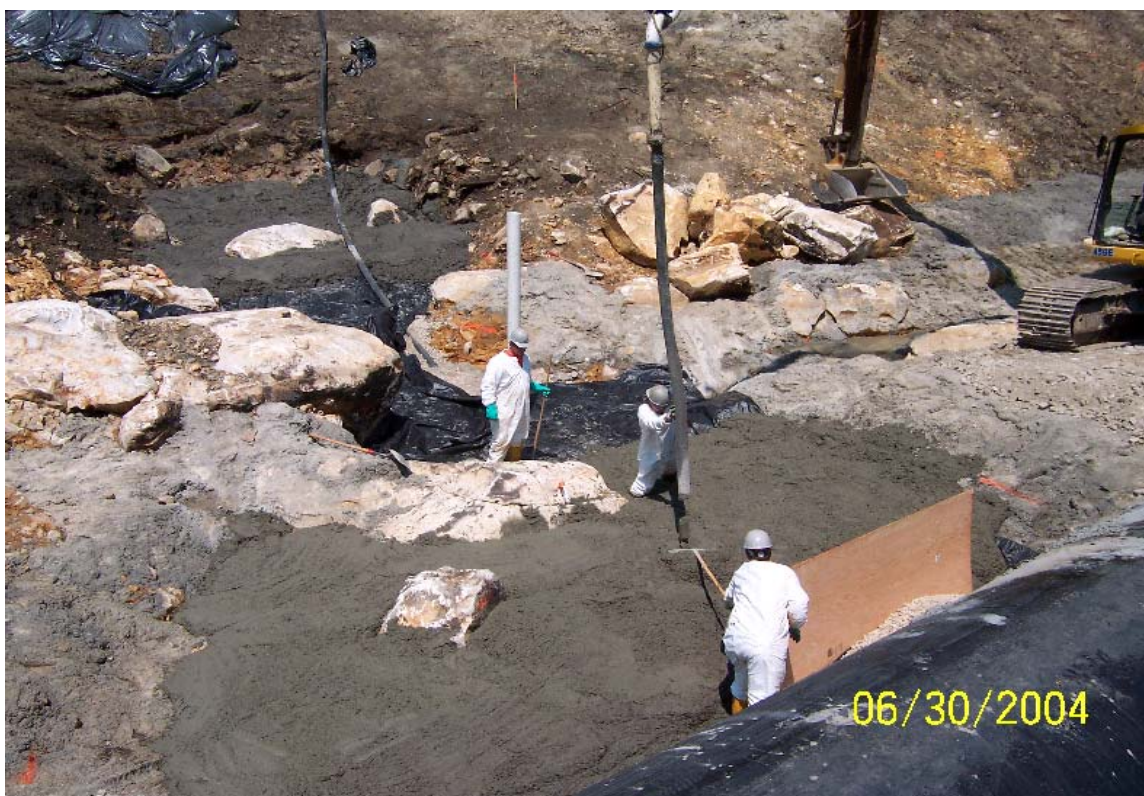
Photograph 6 – Installation of the NAPL Containment/Recovery System

The area of the riverbed where the NAPL-impacted material extended to eighteen feet below grade was encapsulated with a concrete mixture in an attempt to prevent any residual NAPL from leaching out of the bedrock and into the excavated/clean river bottom. However, it was observed that NAPL was still seeping out of the bedrock fractures and through the concrete mixture. Therefore, a NAPL interceptor system was designed to recover and or contain NAPL seeping out of the bedrock. The NAPL interceptor/containment system design consisted of the following. Approximately three-foot layer of $\frac{3}{4}$ inch gravel was to be installed in the bottom of the excavation hole. A 2-inch diameter perforated pipe will be installed within the gravel layer to collect any remaining NAPL. Attached to the perforated pipe will be a tee fitting allowing for the connection of a 2-inch diameter non-perforated HDPE pipe running up the bank and a 6-inch diameter standpipe that would reach an elevation above the designed finished grade at the toe of slope. The 2-inch diameter non-perforated HDPE pipe would run up the riverbank and daylight out of the restored bank above the top of riprap elevation. The 2-inch diameter non-perforated

HDPE pipe would be cased in a 4-inch diameter HDPE pipe to protect the 2-inch diameter non-perforated HDPE pipe during backfill operations. A fitting would be installed on the end of the 2-inch diameter non-perforated HDPE pipe to allow for the connection of a pump to recover any NAPL that seeps into the recovery piping in the river bottom. The 6-inch diameter standpipe located at the toe of slope would allow for a pump to be dropped directly into the recovery system piping for NAPL recovery as well. Non woven geotextile will be installed over the ¾-inch gravel. Grout will be installed on the geotextile to contain any NAPL that collects in the gravel. Common fill, filter material and an eighteen inch layer of 12-inch riprap will be placed on top of the grout to achieve final grade.
